MACON LAKE DAM
MACON COUNTY, MO.
MO 10153

PHASE 1 INSPECTION REPORT NATIONAL DAM SAFETY PROGRAM

PREPARED BY: U.S. ARMY ENGINEER DISTRICT, ST. LOUIS

OCTOBER, 1980

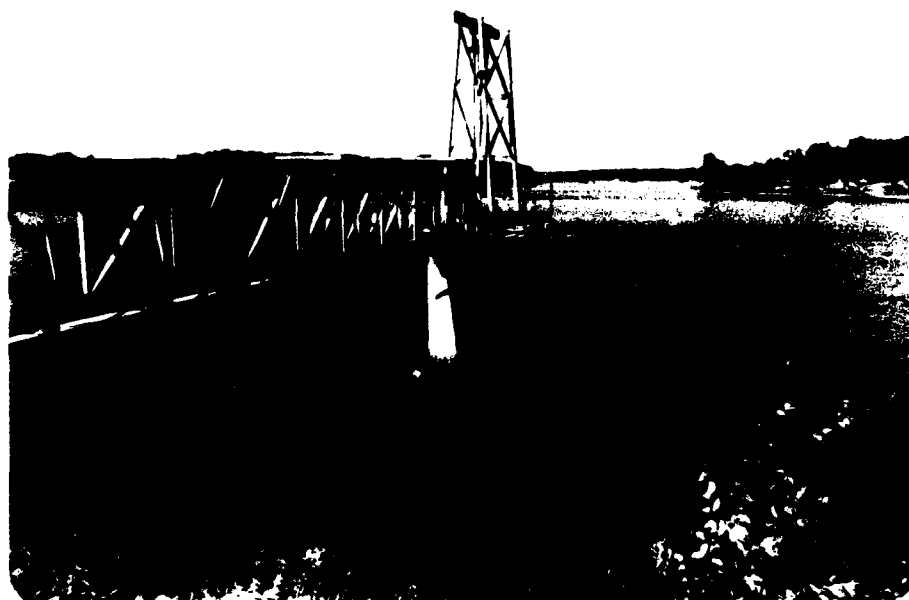
- (2) Outlet works. The outlet works consisting of a gate chamber and two cast-iron outlet pipes, as described in paragraph 1.2a(5) and as shown on the plans (Appendix C) appear to be in good condition and are operated regularly as needed by the city for water supply. Photos 4, 5 and 6 show portions of the outlet works.

PHOTO NO. 6 - CITY WATER SUPPLY INTAKE TOWER FROM CREST

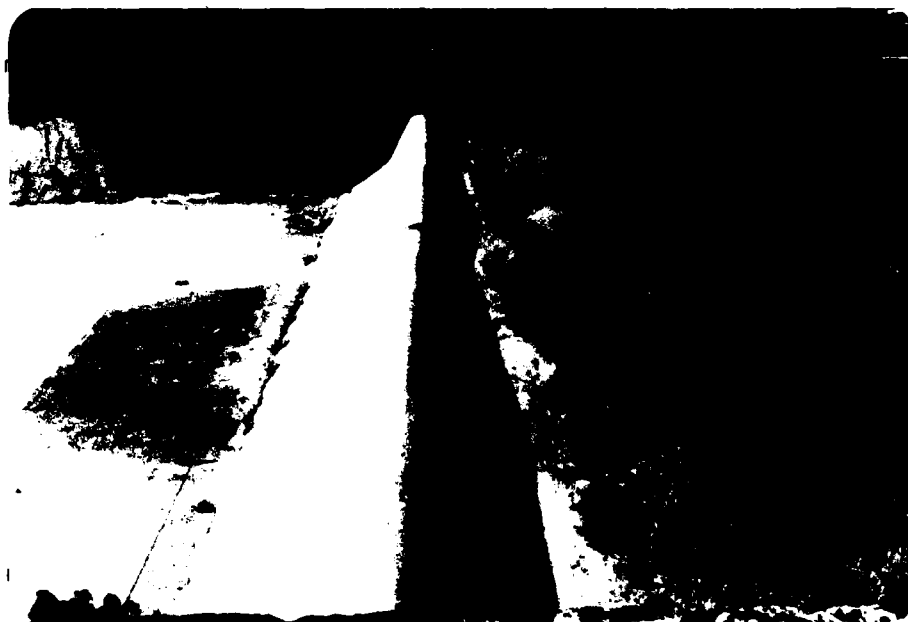
The concrete wing walls and crest of the weir structure appear to be in good condition with one small crack observed in the left wing wall. Photos 11, 13 and 27 show the weir crest and wing walls. Some cracks and spalling were observed in the original weir structure which was capped with 2 feet of new concrete in 1964. Plate 16 shows a crack in the original structure.

PHOTO NO. 11 - LOOKING ACROSS OGEE SPILLWAY CREST FROM
LEFT TO RIGHT

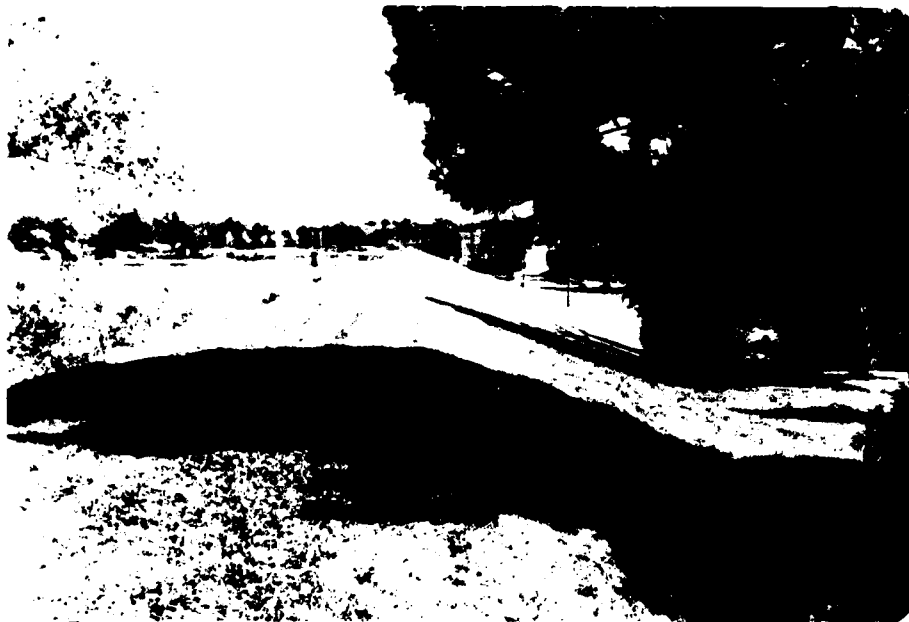
- (3) Crest. The left end of the crest is well gravelled and serves as a roadway to the outlet works. The remainder of the crest is very well vegetated with adapted grasses. Measurements indicate that the profile of the crest is remarkably uniform with only one station below the planned elevation of 800 (Sta. 6+00 @ 799.9). No cracks or deformations were noted along the crest. Photos 4 and 12 show the crest.

- (4) Downstream Slope. The downstream slope is very well vegetated with adapted grasses. No cracks, deformations, rodent activities or seeps were observed on the slope or along the toe of the slope. Photos 5 and 12 show the downstream slope. The ornamental trees in the right abutment trough, shown in Photo 12, should not endanger the embankment. Mr. Jensen reported that a seep area appears intermittently about 70 feet downstream from the toe of the dam near Station 8+00. This seep has been observed ever since the dam was built and would appear to be located in the old natural drainageway. The seep area was dry to a depth of 2 feet below the surface at the time of inspection. Photo 28 shows the seepage area.

PHOTO NO. 12 - CREST AND DOWNSTREAM SLOPE FROM RIGHT END
